# NO BARRIER TO PROGRESS

EXTENDED LIFE FOR LONDON'S ICONIC FLOOD DEFENCES

**S**panning 520m across the river at Woolwich, the Thames Barrier has protected London from flooding for almost three decades. The city's long-term defence strategies hinge on the barrier continuing to fend off tidal surges. Halcrow has played a key role in an ongoing maintenance and refurbishment project since 2001. →

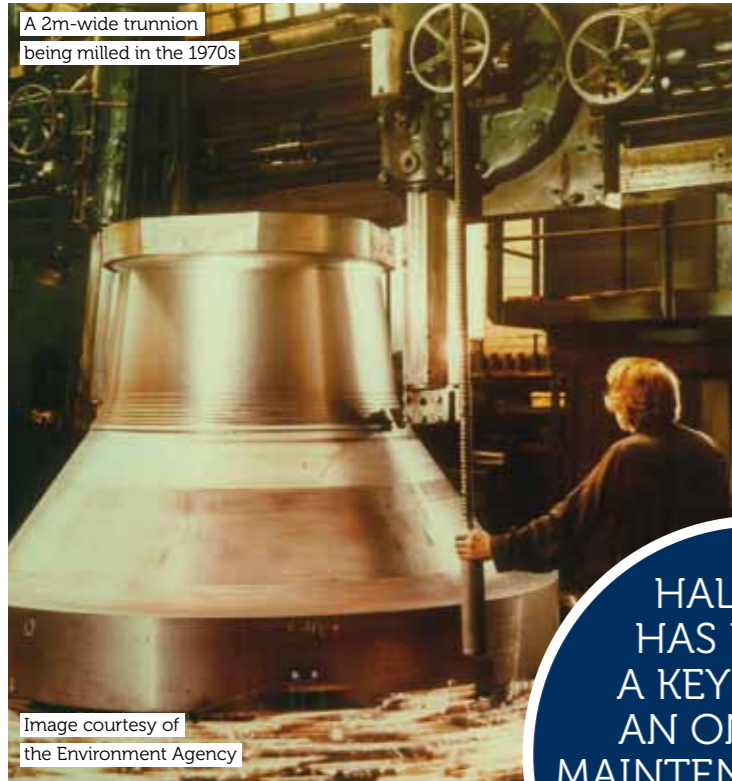
A 2m-wide trunnion being milled in the 1970s

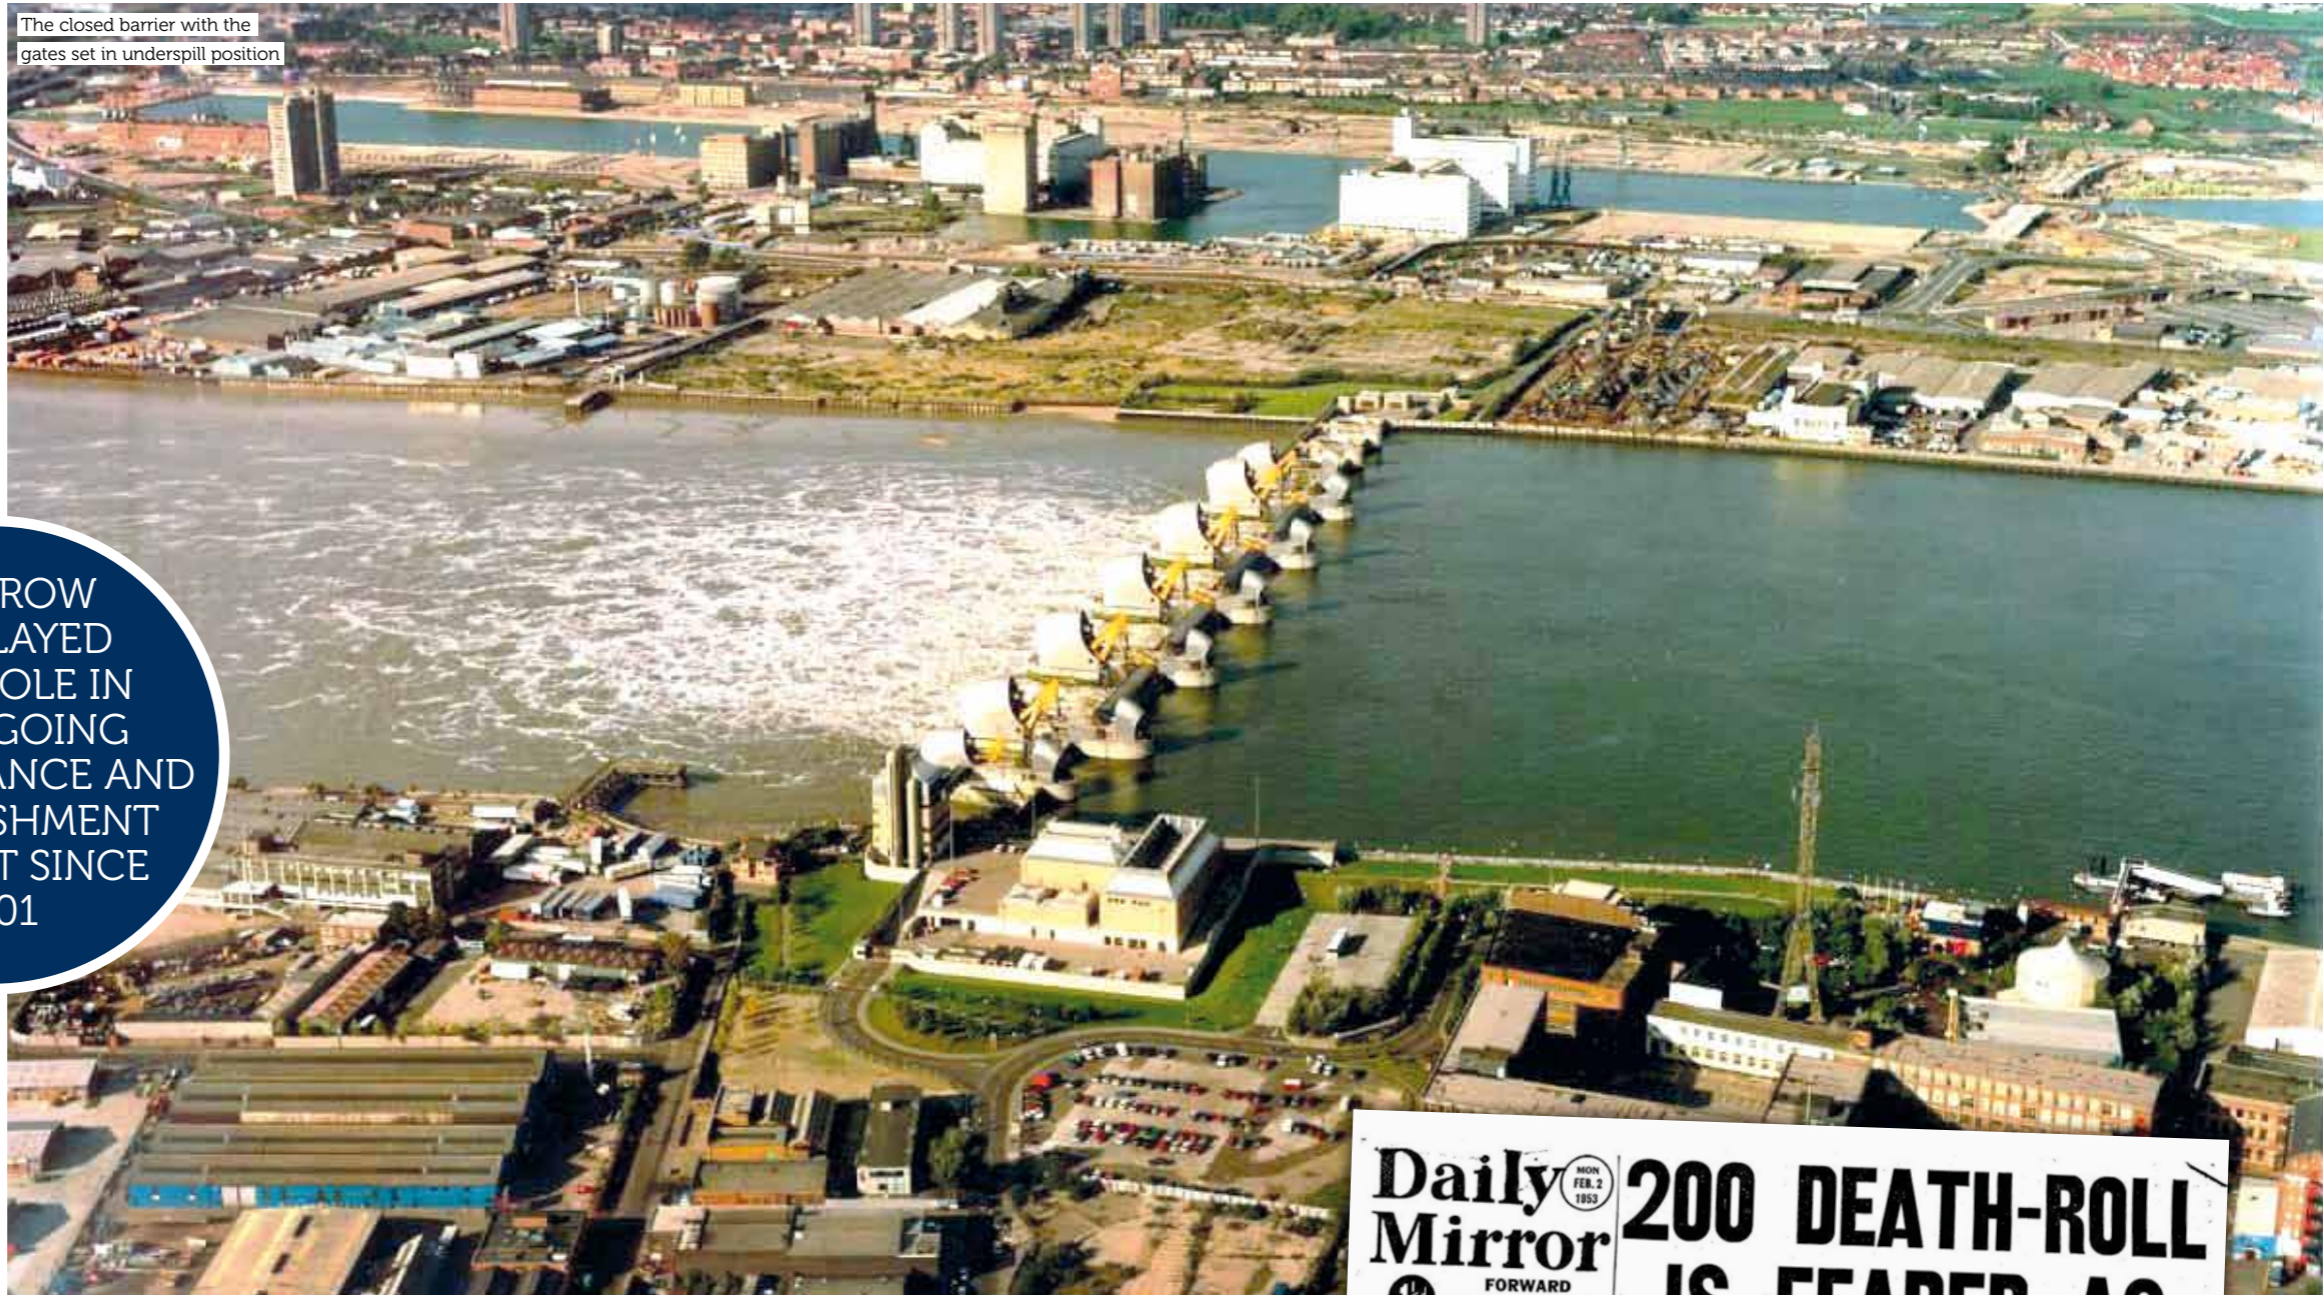
The closed barrier with the gates set in underspill position

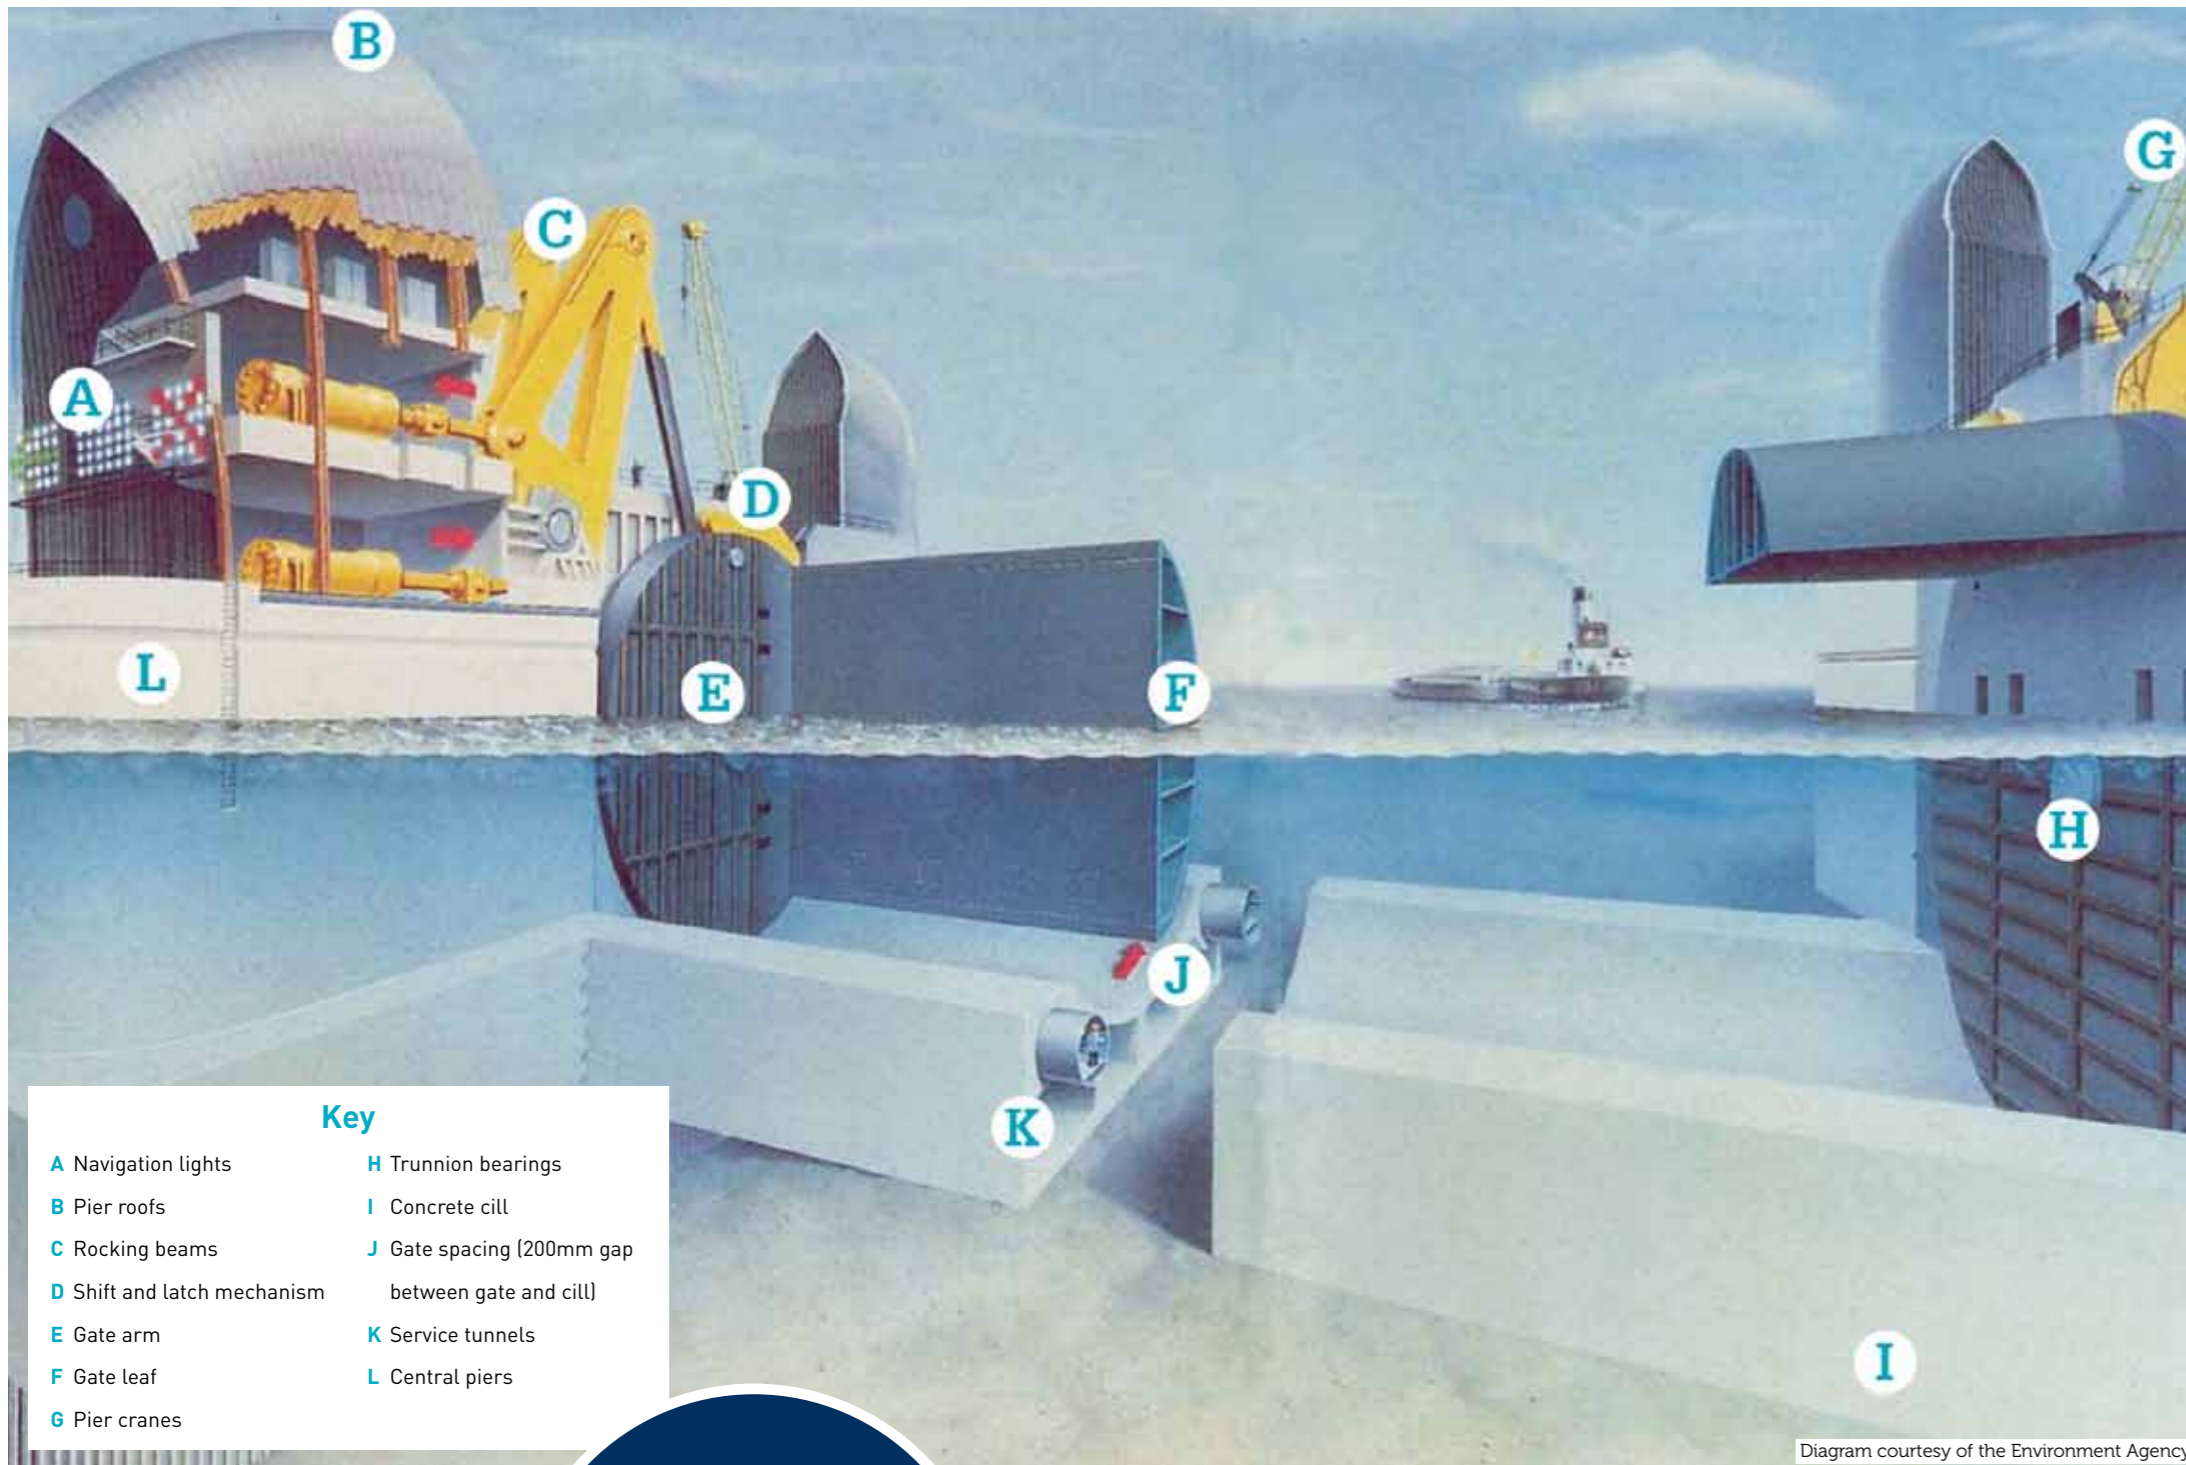
Diagram courtesy of the Environment Agency

Following the four-year assessment and upgrade project, Halcrow was retained in 2008 to assist the Environment Agency as it undertook repairs on the main rising sector gate bearings. The barrier's four main gates, each 62m long and weighing 3,500 tonnes, rotate around a 2m-wide

bearing mounted on a steel cone, or trunnion. The trunnions are fixed to the river piers by three post-tensioned bar systems, each capable of taking the full load of the closed gates.

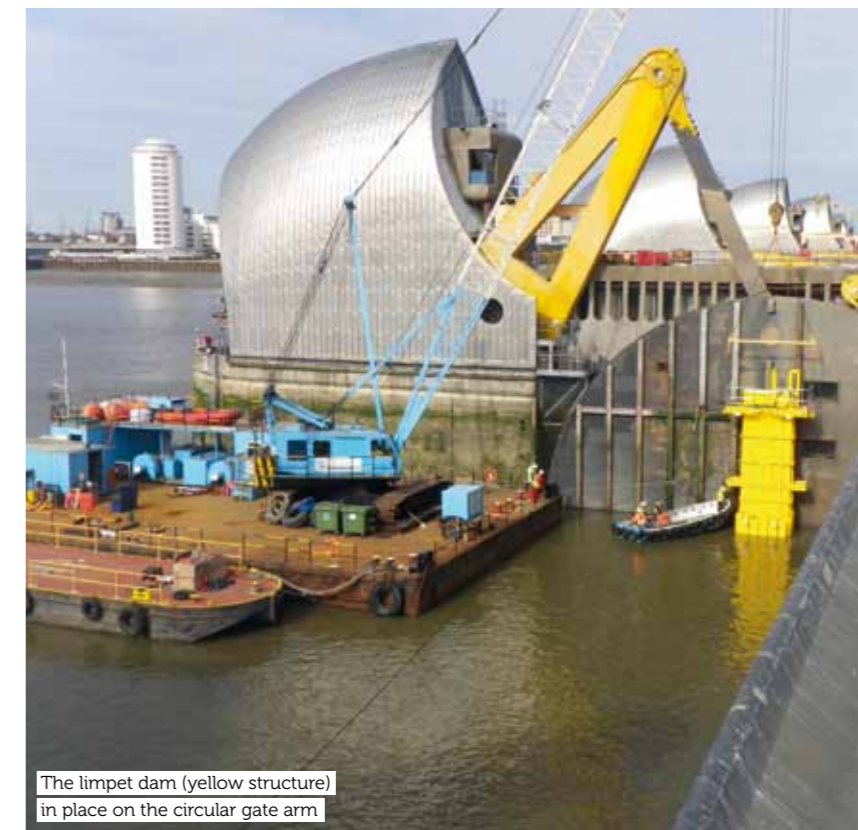
The limpet dam (yellow structure) in place on the circular gate arm

A specially developed limpet dam provided safe access to the bearings, which sit below the low-tide water level. "We found that some of the post-tensioned bars no longer met the performance requirements," said senior project manager Jon Holland. "We worked closely with the client and the contractor, VolkerStevin, to safely re-tension or replace these during

With work being undertaken below the low-tide mark, a specially designed limpet dam was used to allow the team access to the bearing for assessment and re-stressing. The structure is submerged against the gate arm and the water pumped from its body to provide dry working access.

The dam is equipped with ventilation, lighting and power, as well as mechanical handling equipment for the bearing cover plate and tensioning tools.

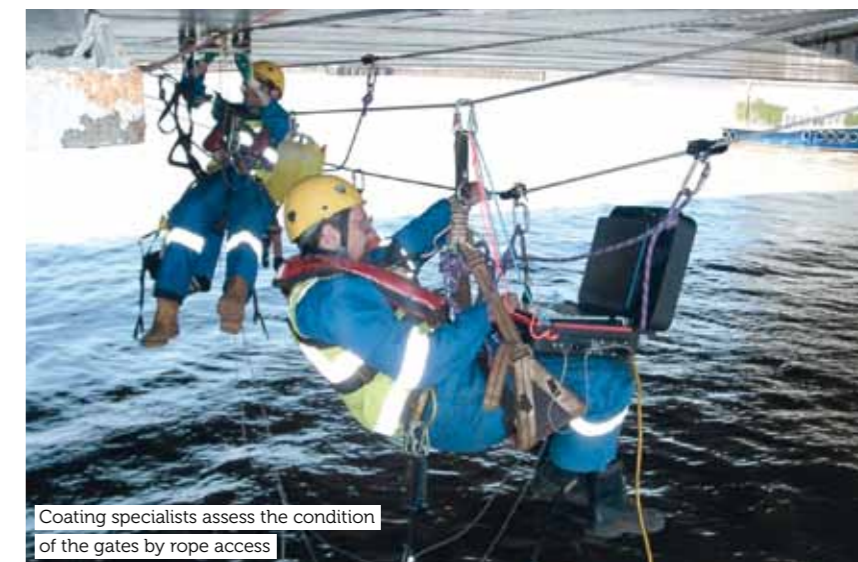
Coating specialists assess the condition of the gates by rope access
