Turning up the heat – full service fire safety engineering for concrete structures

JEREMY INGHAM AND FATHI TARADA, HALCROW GROUP LIMITED

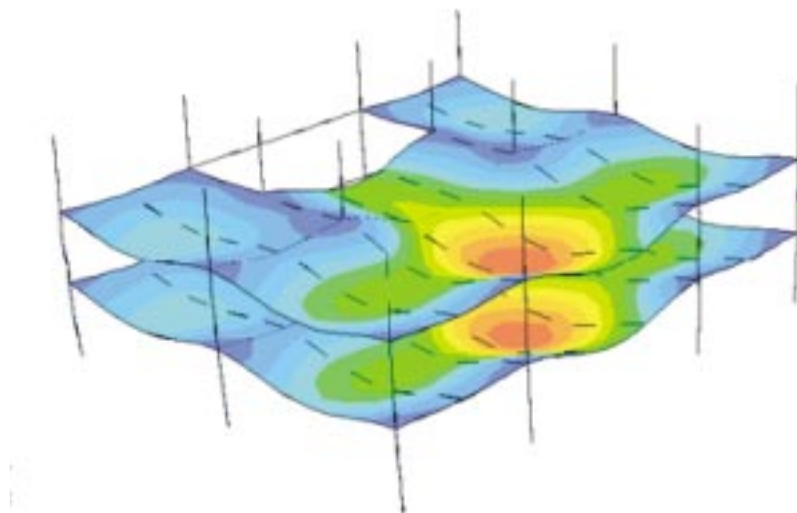
Figure 1: Finite element analysis of the deflection profile for a composite concrete floor slab at elevated temperatures.

This involves carrying out the necessary structural fire analysis to predict the stability of the whole structure, based on the results of the previous stages, using a computer model (see Figure 1). It is important to note that the stability of the member and overall structure depends on the following factors:

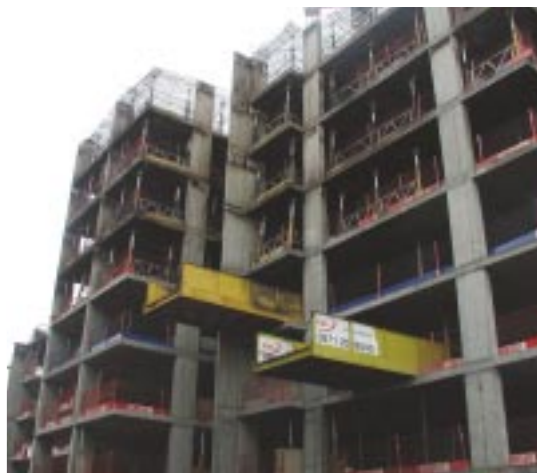
Figure 2: The concrete frame of a ten-storey building that was fire-damaged during construction.

Concrete structures most likely to be subjected to fire include buildings such as offices, warehouses and schools. Other common scenarios involve vehicle fires in car parks or tunnels. In recent years a number of notable fires have occurred during construction of concrete-framed buildings, when formwork and falsework has caught fire (see Figure 2). Fortunately, even after a severe fire, reinforced concrete structures are generally capable of being repaired rather than demolished. Guidance for the assessment and repair of fire-damaged concrete structures is provided in Concrete Society Technical Report 33⁽²⁾. This publication is currently being revised by a Concrete Society Working Group that includes Halcrow engineers.

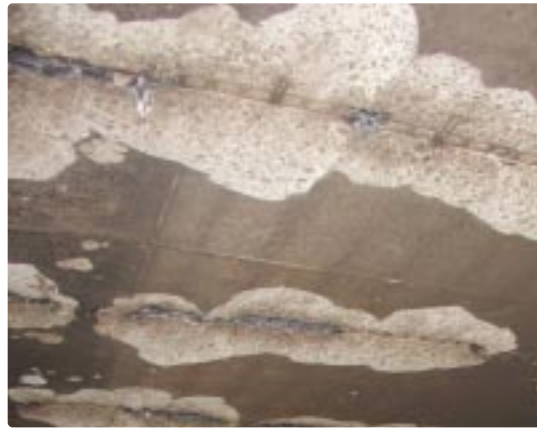
Figure 3 right: View of the interior of a fire-damaged building showing spalling of a reinforced concrete slab soffit.

Spalling of the surface layers of reinforced concrete is a common effect of fires. Explosive spalling (see Figure 3) is erratic and generally occurs in the first 30 minutes of the fire. A slower spalling ('sloughing off') occurs as cracks form parallel to the fire-affected surfaces. Forms of cracking include those caused by differential thermal expansion, and thermal shock from quenching by fire-fighting water. Also, differential incompatibility between aggregates and cement paste may cause surface crazing.

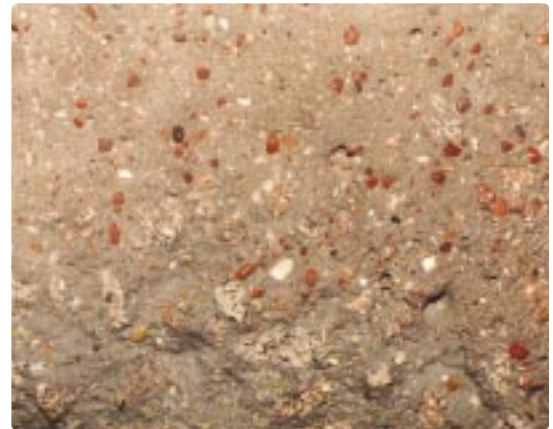
Figure 4 far right: View of a fire-damaged concrete column showing red discoloration of flint fine aggregate particles.

Heating can change the colour of concrete and this may indicate the temperature attained. At above 300°C a red discoloration is important as it coincides approximately with the onset of significant strength loss. Consequently, any pink/red discoloured concrete should be regarded as being potentially weakened. Actual concrete colours observed depend largely on the types of aggregate present in the concrete. Colour changes are most pronounced for

siliceous aggregates and less so for limestone, granite and sintered pulverised fuel ash. Perhaps the most striking colours are produced by flint (see Figure 4). The red colour change is a function of (oxidisable) iron content and it should be noted that not all aggregates undergo colour changes on heating. Also, due consideration must always be given to the possibility that the pink/red colour may be a natural feature of the aggregate rather than heat-induced. A number of complementary non-destructive techniques can be used to assess material strength in-situ. These include Schmidt (rebound) hammer and ultrasonic pulse velocity (UPV). Samples of damaged material (and undamaged references) may be removed for laboratory investigation, often by diamond drilling of cores. If it is suspected that the reinforcement bars have been heat damaged it will be necessary to obtain samples and test the tensile strength in the laboratory.

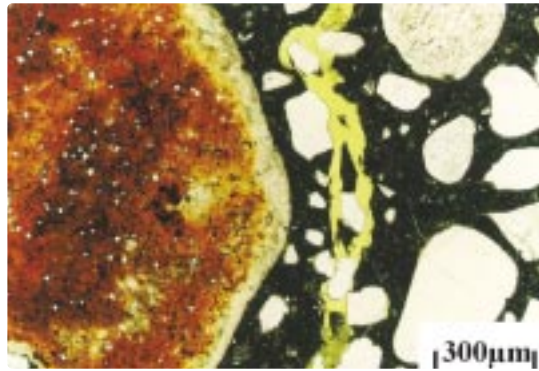
Figure 5 right: A photomicrograph of fire-damaged concrete showing a crack running parallel to the outer surface and red discoloration of a flint fine aggregate particle.

The temperature profile for each concrete element is commonly estimated using a combination of on-site visual inspection and testing, and petrographic examination of samples in the laboratory. Petrographic examination performed in accordance with ASTM C856⁽⁴⁾ is invaluable in determining the heating history of concrete, as it can determine whether features observed visually are actually caused by heat rather than some other cause⁽⁵⁾. In addition to colour changes, the heating temperature can be cross-checked with changes in the cement matrix and evidence of physical distress such as cracking (see Figure 5). The combined investigative findings are used to prepare key diagrams and schedules detailing the damage. A comparison between the cost of repair and the cost of removal and replacement is then made for each damaged element, taking into account its function. Following this, a repair strategy may be drawn up.

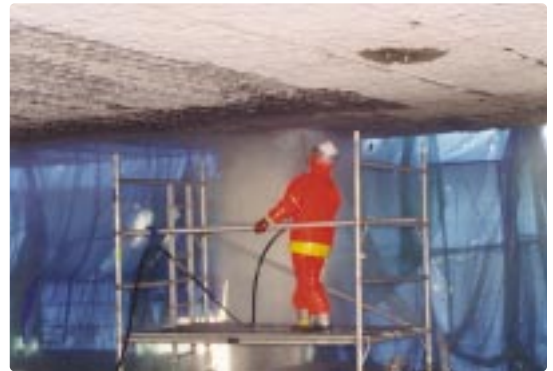
Figure 6 far right: Removal of fire-damaged concrete by water jetting.

Concrete element repair will usually include three main processes, the first being removal of damaged concrete by using either power breakers or water jetting (see Figure 6). After a severe fire it is likely that the second process will comprise removal of weakened reinforcement and connection of new reinforcement. The final part of the repair stage will comprise reinstatement of concrete to provide adequate structural capacity, the necessary durability and fire resistance, and an acceptable appearance (see Figure 7). An alternative to providing additional steel reinforcement is the use of fibre composite materials (FRPs), bonded to the surface using an epoxy adhesive.

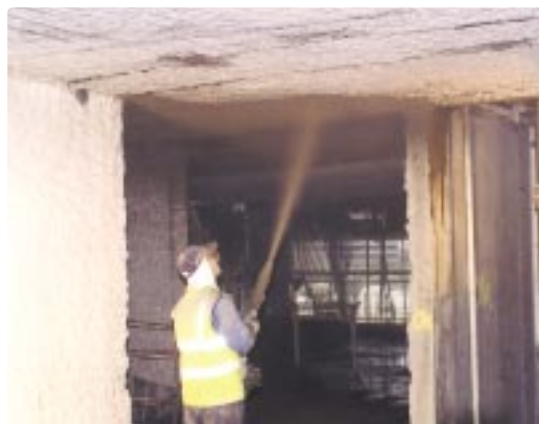
Figure 7: Application of sprayed concrete to repair a fire-damaged slab soffit following removal of fire-damaged concrete.
